Outlook 30 Knots - We Get to Thoroughly Thrash

A Real Boat Test!

The Seaforce Fisherman 600

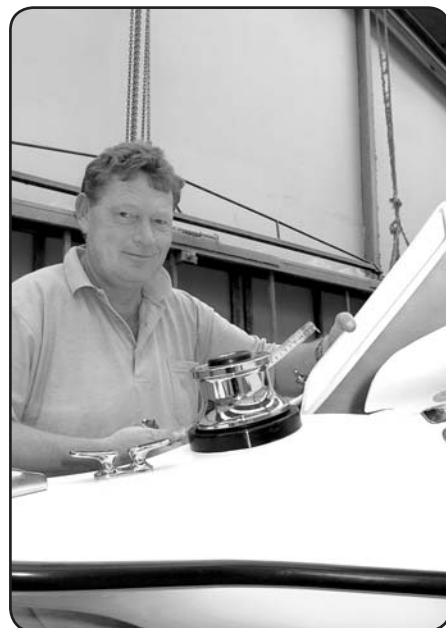
A week after my test of the boat I went to Seaforce to take a couple of photos in the factory. I found Ric Lawrence already at work making a glass moulding for the winch cover. His dedication to producing the best possible product is very impressive.
